FIELD EXPERIENCES WITH RUB INDUCED INSTABILITIES IN TURBOMACHINERY*

David G. Goggin
Radian Corporation
P.O. Box 9948
Austin, Texas 78766

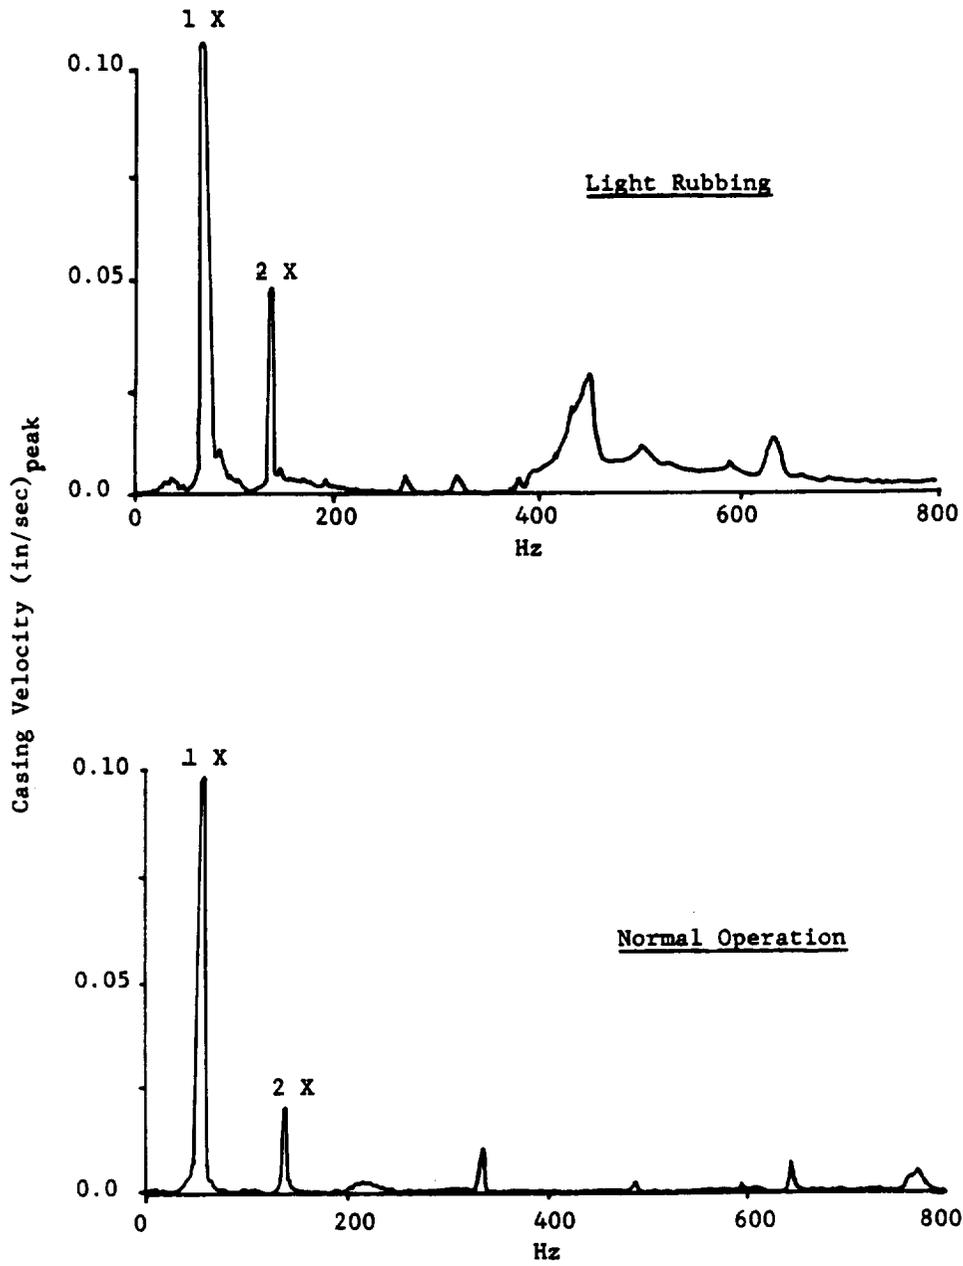
Figure 1. - Turbine case vibration on a 5000 kw turbine-generator.

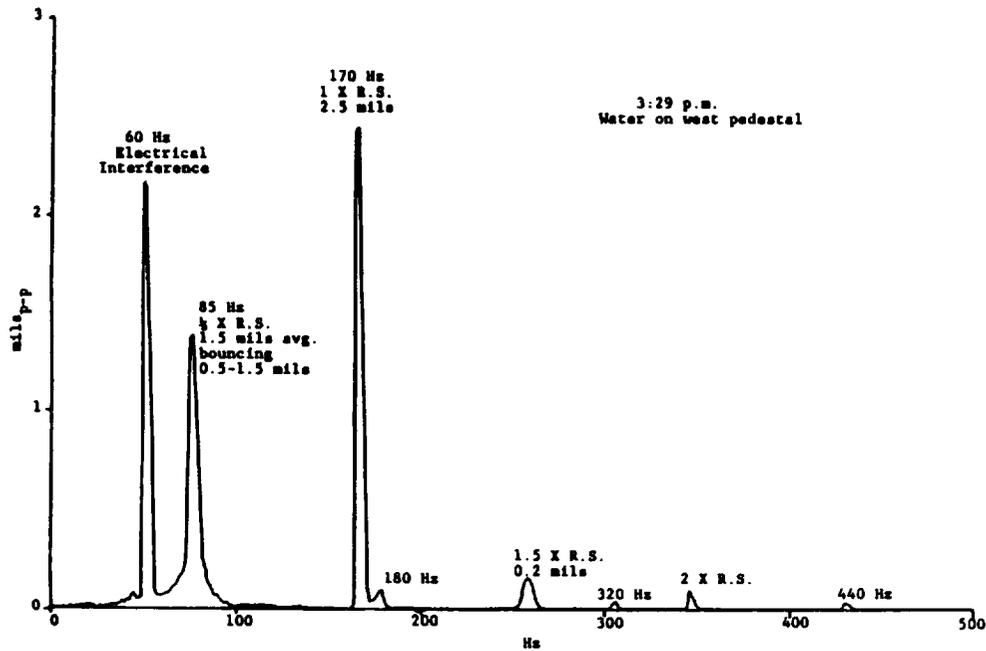
Another identical unit exhibited the same instability characteristics. This unit had developed a history of vibration problems during its eleven years of operation. One problem was occasional bouts of fluctuating high vibration at the topping turbine discharge end bearing. It had been found that using water on the bearing pedestals to change the alignment would sometimes reduce or eliminate the vibrations. An analysis was made during one vibration excursion to determine what effect the water was having. Figure 3 shows a spectra taken at 3:29 p.m. with water being used on one pedestal. There was a running speed vibration of $64 \mu\text{m}$ (2.5 mils) at 10,200 rpm (170 Hz) and a $1/2$ running speed peak of $38 \mu\text{m}$ (1.5 mils). The $1/2$ running speed peak was superimposed over the normal band of low level subharmonic noise and there was some electrical interference at 60 Hz, 120 Hz, 180 Hz, etc. The water was taken off the pedestal and figure 4, taken at 3:35 p.m., shows the resulting increase in the subharmonic. The water was then put on the other pedestal and the results are shown in figure 5, taken at 3:47 p.m. The instability had ceased suddenly and the running speed vibration slowly decreased from $64 \mu\text{m}$ (2.5 mils) to $38 \mu\text{m}$ (1.5 mils). During a subsequent outage, the bearings and seals at this point were inspected and found to be severely rubbed over a bottom quarter of their diameter. It was concluded that this was another rub which had produced both a large subsynchronous component as well as an increase in the unbalance from non-uniform heat input to the shaft. Once the rub was removed by changing the alignment, the subharmonic component ceased suddenly and the running speed vibration returned to normal slowly.

Figure 3. - Topping turbine discharge end vibration - with water on west pedestal.

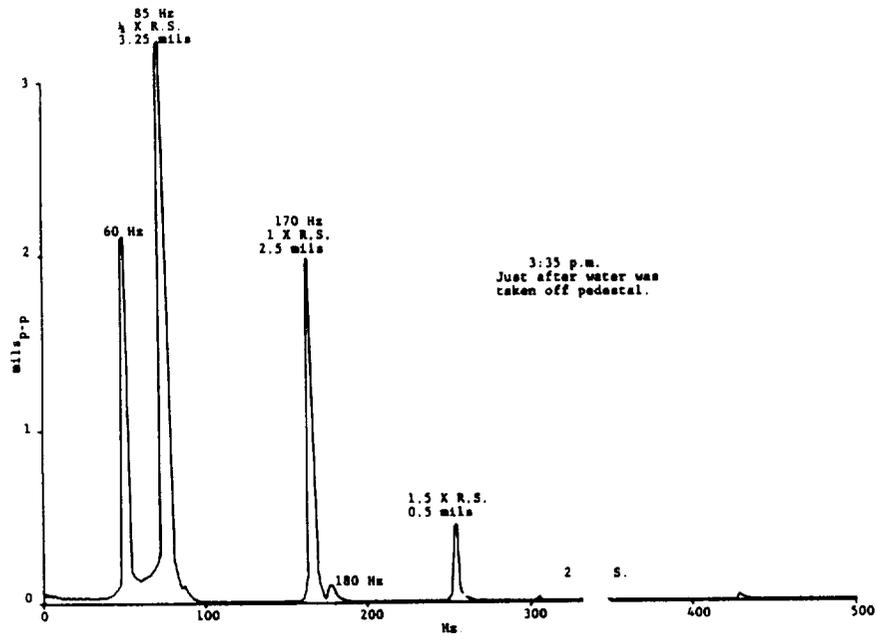
Figure 4. - Topping turbine discharge end vibration - water taken off pedestal.

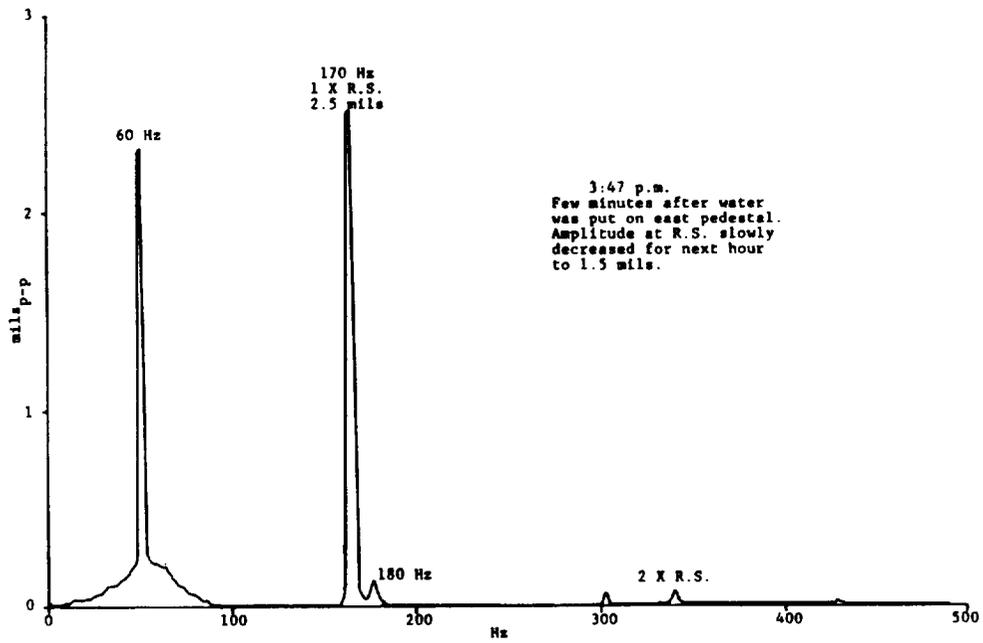
Figure 5. - Topping turbine discharge end vibration - with water on east pedestal.

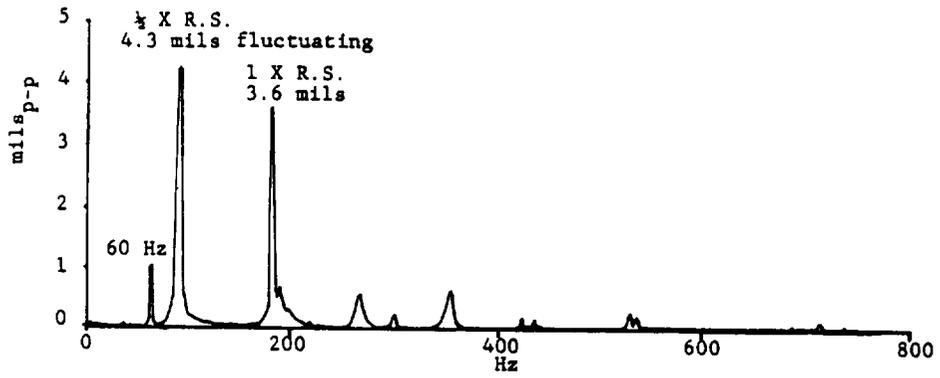
Figure 6. - During vibration excursion.

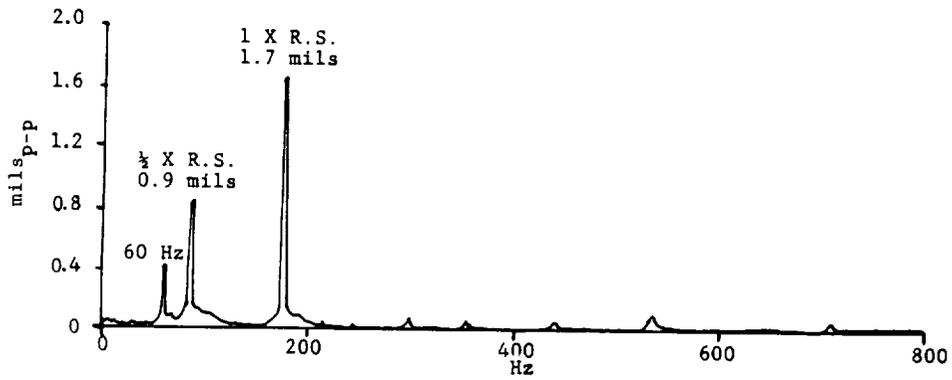
Figure 7. - At conclusion of vibration excursion.

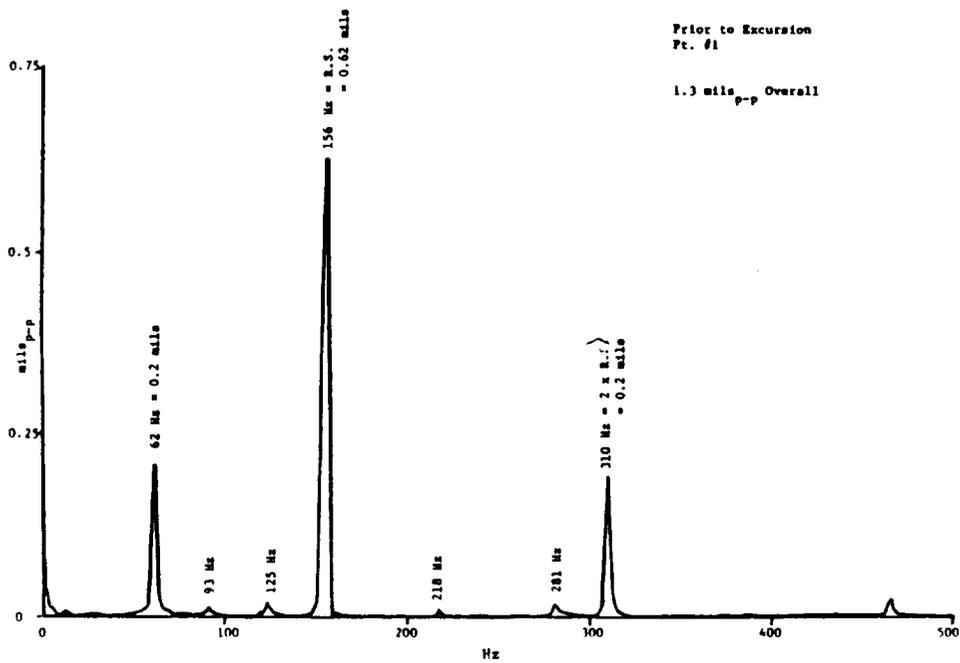
Typical frequency spectra from just prior to and just after the start of a vibration excursion are shown in figures 9 and 10 respectively while operating at 9360 rpm (156 Hz). The transition time between figure 9 and figure 10 was less than 0.1 second. The overall vibration level had been 33 μm (1.3 mils) with 15.7 μm (0.62 mils) at running speed and approximately 5 μm (0.2 mils) at 62 Hz or 2/5 of running speed. During the excursion, the vibration level increased to approximately 76 μm (3 mils) with the majority of this increase due to the 62 Hz component. The amplitude of the subsynchronous component averaged about 53 μm (2.1 mils), but was fluctuating wildly over a range as wide as 13 to 89 μm (0.5 to 3.5 mils) but typically from 38 to 64 μm (1.5 to 2.5 mils). The orbit developed into a "double orbit" from a relatively circular one and the whirl direction was noted to be forward. Various other frequencies noted during the excursion were found to be sum and difference frequencies of the two dominant frequencies of 62 Hz (subsynchronous vibration) and 156 Hz (running speed). These are shown in more detail in figure 11. A very narrow band analysis verified that the subsynchronous component was 2/5 of running speed to within 0.1 Hz.

Figure 9. - Turbine outboard bearing - just prior to excursion.

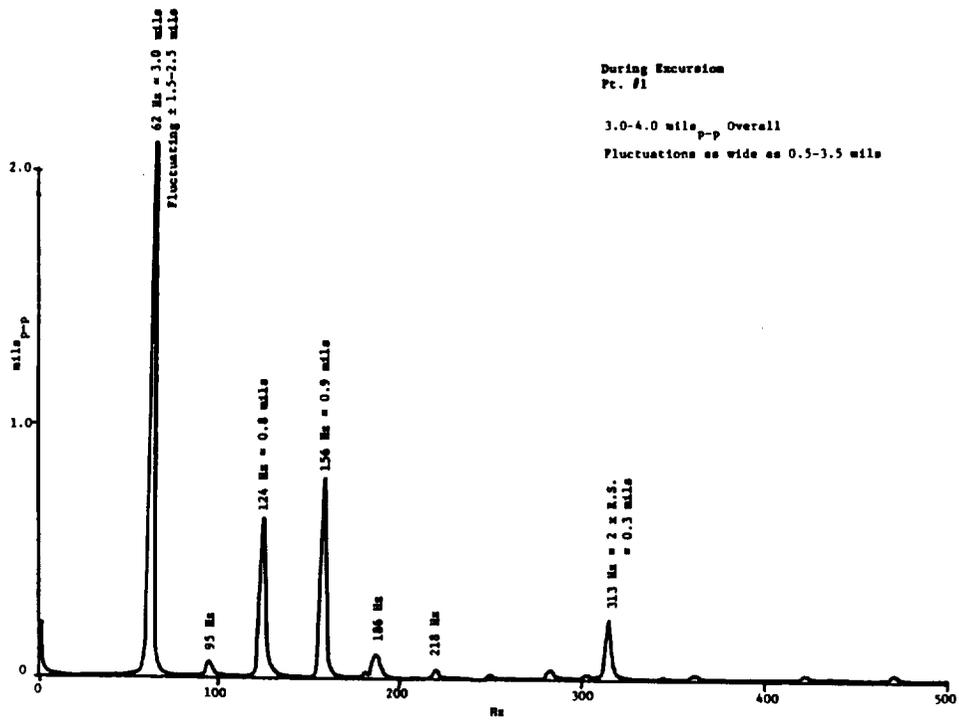
The problem was thought to be due to a transient rub condition since:

- 1) the condition was closely related to weather conditions,
- 2) the wide fluctuations in the subharmonic component,
- 3) that slight increases in speed caused the instability to cease.

- 2) A sliding key at the turbine governor end meant to maintain axial alignment while sliding to accommodate thermal growth, had frozen preventing the case from moving axially.
- 3) The bearing oil seals were lightly rubbed.
- 4) The rotor was heavily rubbed at the center by the interstage labyrinths.

It was concluded that the frozen footing was primarily responsible for the rubs. The case was apparently bowing in the center quite severely during sharp thermal transients as it tried to accommodate the change in casing growth and pipe strain. This also was thought to be the reason for the rub during start-up since the case again could not shift to accommodate thermal growth. Although other rubs had probably occurred at some time in the machine's history, there had been none this severe as indicated by the depth of scoring on the rotor. This explained why this problem had not occurred before.

Figure 10. - Turbine outboard bearing - during vibration excursion.

The rotor was realigned and the frozen footing was freed. The machine has since operated for a year and a half with no further problems except for the usual problem of thermal bows during startups.

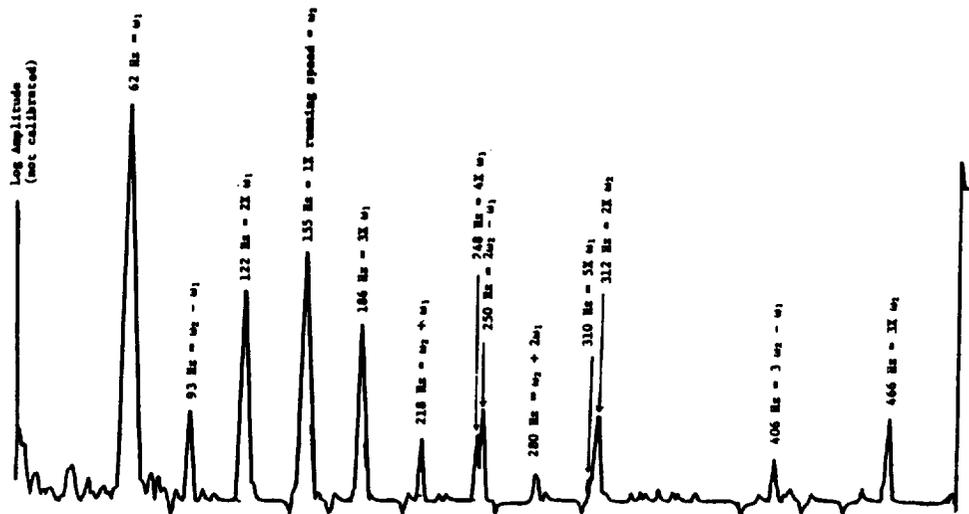
Figure 11. - Turbine vibration - during excursion: sum and difference frequencies.
